TOOLBOX

**SAFETY
TRAINING**

Vol 32 - No 13 CIRCULAR SAW ACCIDENT

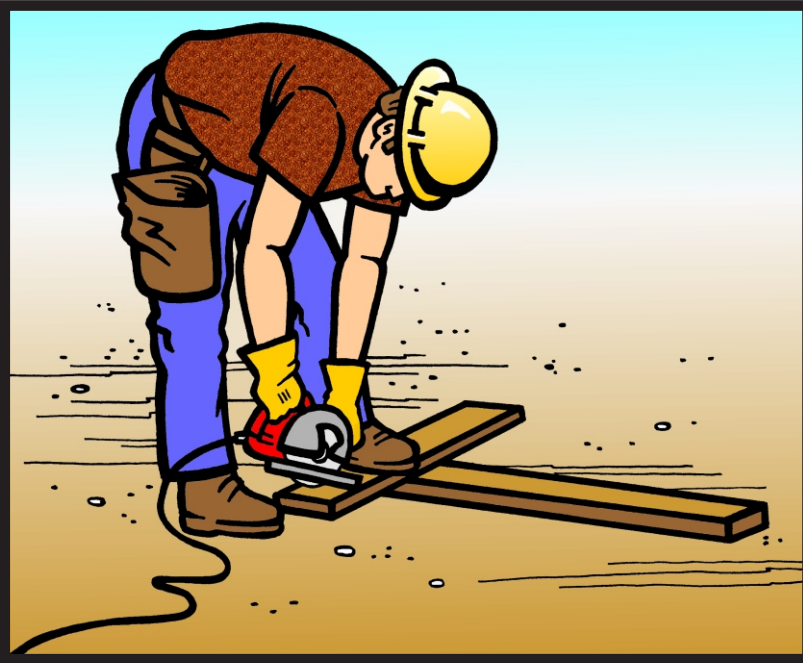
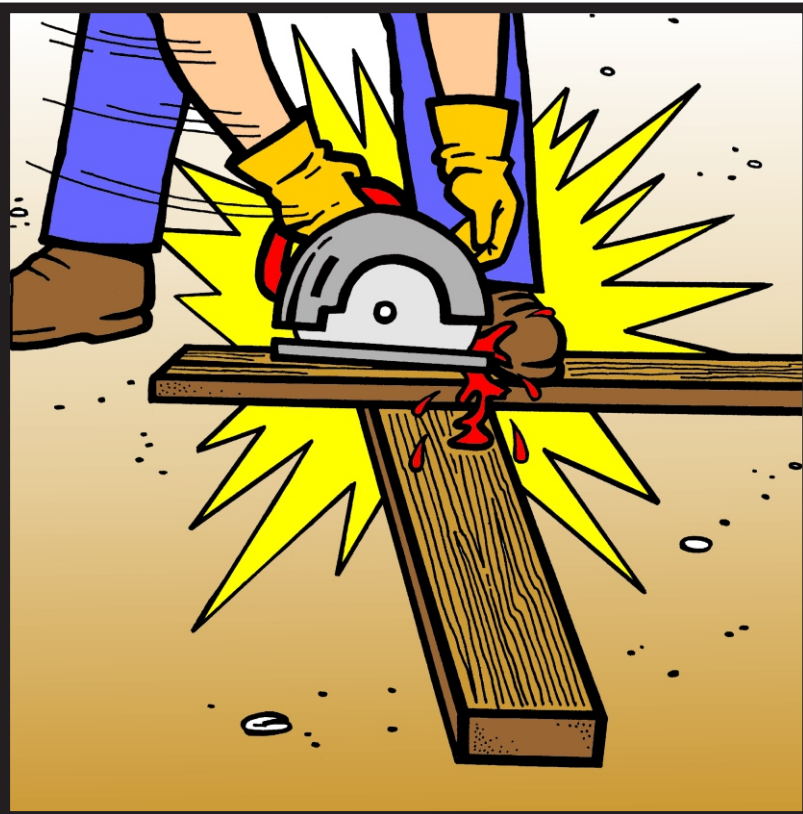
An employee with 7 years experience was ripping a 2x4 in half with a circular saw to use as forming stakes. He placed a 2x4 underneath so the board he was cutting was raised off the ground. He proceeded to run the saw through the top of his boot and cut his toe. The head carpenter helped him to a wood pile where his boot was removed. Bandages were put on his toe and 911 was called.

Upon investigation of the accident it was determined that the major factor that contributed to the incident was the improper way the 2x4 was being cut. It should have been placed on a saw horse or on a cutting table, then secured by holding it tightly with the worker's hand completely out of the way or secured by clamps. This accident could have been prevented had the worker followed the safe operating rule of securing the work piece. Instead, he took the fast easy way and paid the consequence.

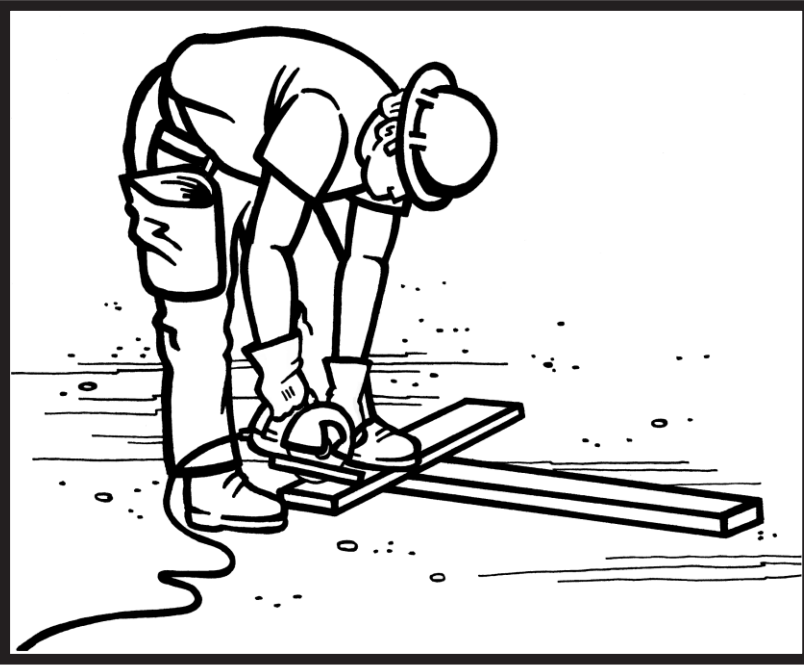
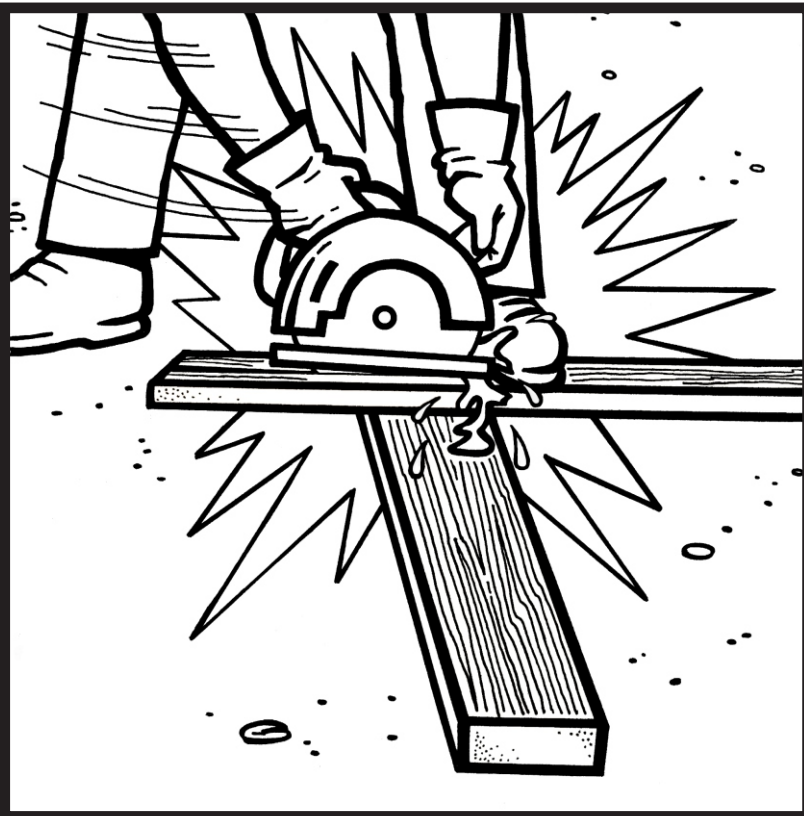
An employee with 7 years experience was ripping a 2x4 in half with a circular saw to use as forming stakes. He placed a 2x4 underneath so the board he was cutting was raised off the ground. He proceeded to run the saw through the top of his boot and cut his toe. The head carpenter helped him to a wood pile where his boot was removed. Bandages were put on his toe and 911 was called.

Upon investigation of the accident it was determined that the major factor that contributed to the incident was the improper way the 2x4 was being cut. It should have been placed on a saw horse or on a cutting table, then secured by holding it tightly with the worker's hand completely out of the way or secured by clamps. This accident could have been prevented had the worker followed the safe operating rule of securing the work piece. Instead, he took the fast easy way and paid the consequence.
