# TOOLBOX

**Vol 31 - No 52**

### **PALLET JACK ACCIDENT**

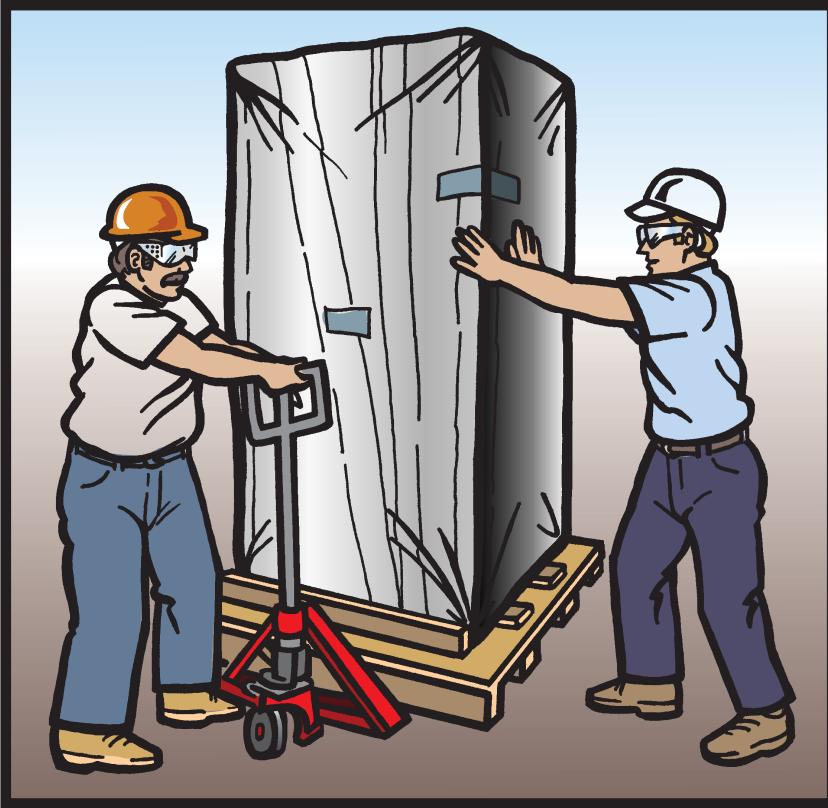
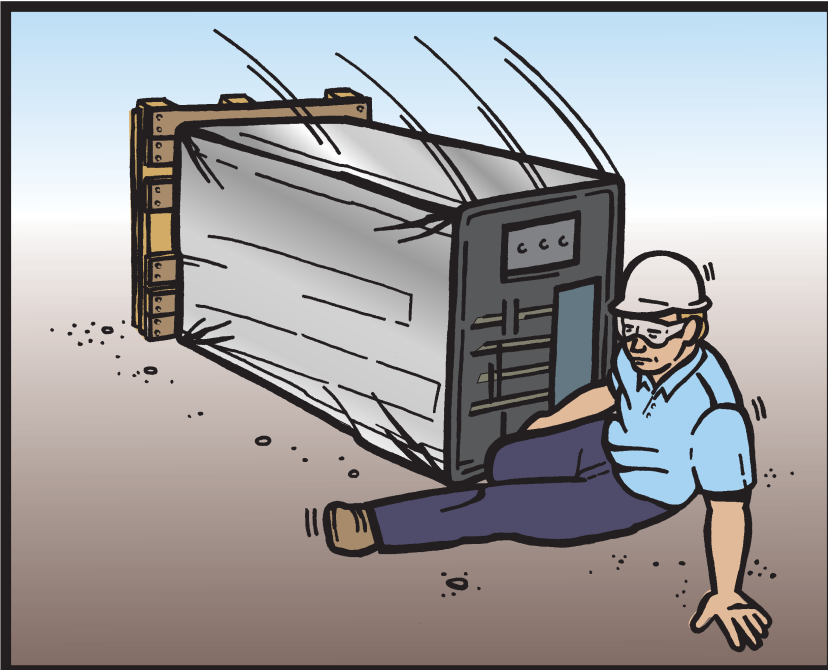
Two employees were moving a battery cabinet from the loading area to the main electrical room with a pallet jack. The cabinet itself weighed 2600 lb, stood over 6' tall, and was top heavy. As one employee was pushing the cabinet the job of the second employee was to hold the cabinet steady. The accident occurred when the workers were trying to turn a tight corner too quickly. A pallet jack by design has three points of contact to the surface of the floor. When they suddenly turned, the weight of the cabinet shifted and fell over on top of the employee trying to hold it steady. Another factor that contributed to the accident was that the pallet jack was raised to its highest position. The employee's right leg was snapped between his knee and ankle. He was out of work for an extended period of time for recovery and rehabilitation.

1. Always pre-plan any moving of materials. Walk the route of travel that is to be taken and note any areas of concern.
2. Always travel with the load as close to the floor as possible and at a suitable speed. Never be in a hurry when safety is involved.

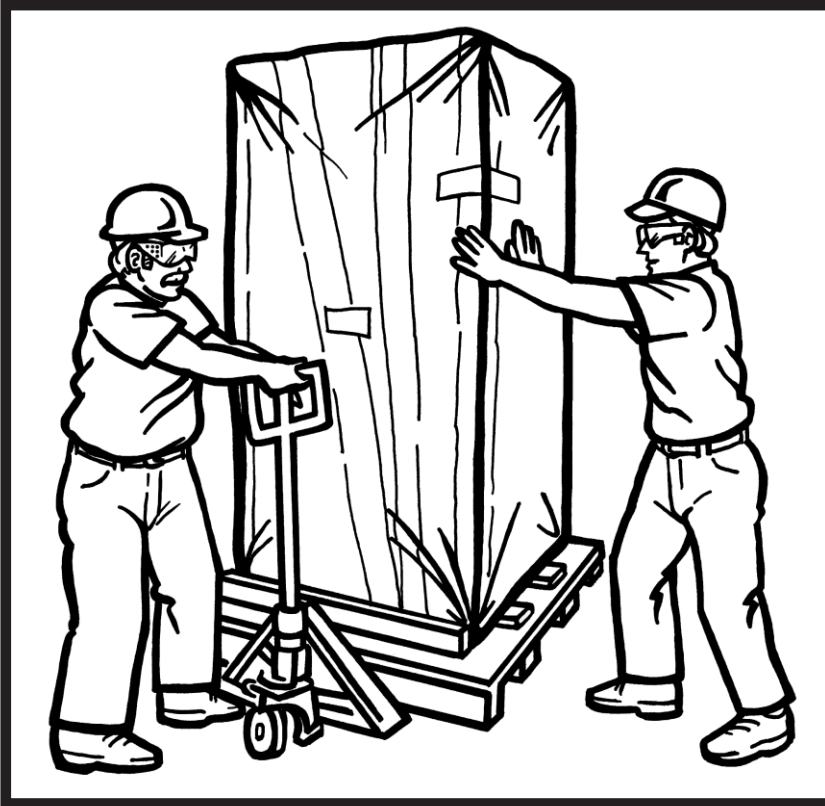
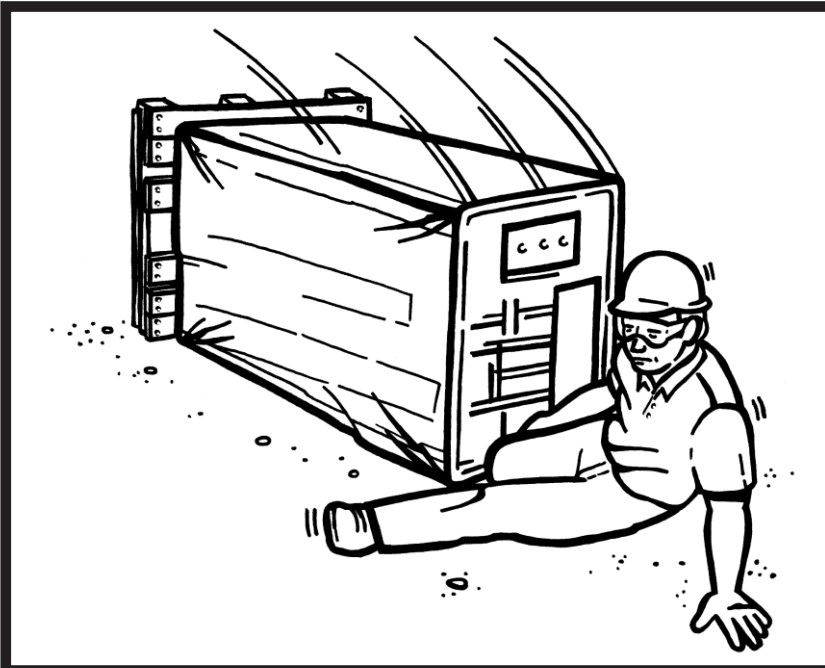
Two employees were moving a battery cabinet from the loading area to the main electrical room with a pallet jack. The cabinet itself weighed 2600 lb, stood over 6' tall, and was top heavy. As one employee was pushing the cabinet the job of the second employee was to hold the cabinet steady. The accident occurred when the workers were trying to turn a tight corner too quickly. A pallet jack by design has three points of contact to the surface of the floor. When they suddenly turned, the weight of the cabinet shifted and fell over on top of the employee trying to hold it steady. Another factor that contributed to the accident was that the pallet jack was raised to its highest position. The employee's right leg was snapped between his knee and ankle. He was out of work for an extended period of time for recovery and rehabilitation.

1. Always pre-plan any moving of materials. Walk the route of travel that is to be taken and note any areas of concern.
2. Always travel with the load as close to the floor as possible and at a suitable speed. Never be in a hurry when safety is involved.
