# TOOLBOX

## **Vol 32 - No 21 CRANE ACCIDENT**

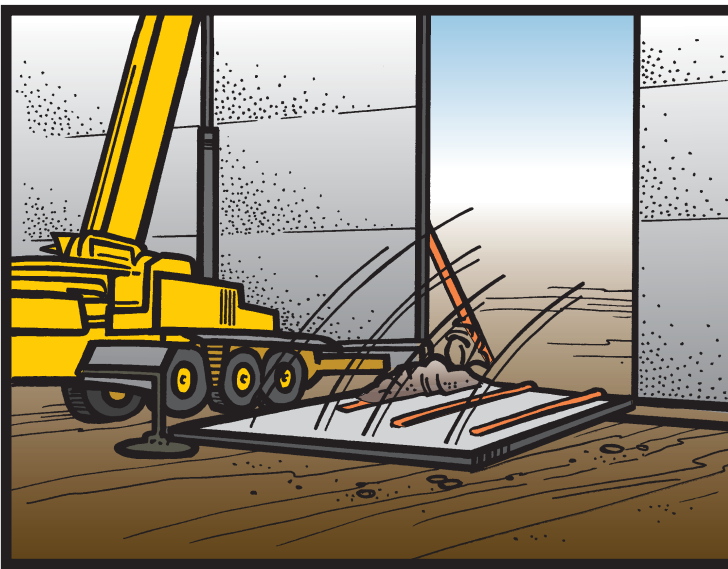
Employees were attempting to install a concrete pre-cast panel into position. As the operator of the crane attempted to position a piece of the wall, it came inwards of building. The operator then jerked it backward to try to compensate. At this time the walk-out wall clipped an adjoining tilt wall. As a result, the tilt wall fell down to the ground level causing total damage to the wall. In addition, one of the cranes outriggers got struck and damaged by the tilt wall as it came down. It's lucky no one was under the wall at the time.

The bottom line in this case is inexperience. The crane operator had not been properly trained for the job that he was required to do. The General Contractor should assure that all subcontractors that operate equipment (cranes, backhoes, skytraks) at any of their job sites have proof of proper training / certification and qualified experience for the equipment being used

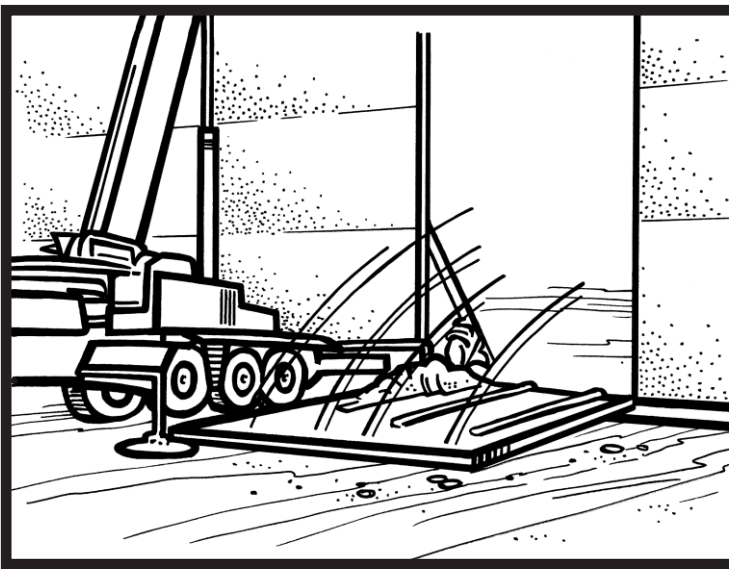
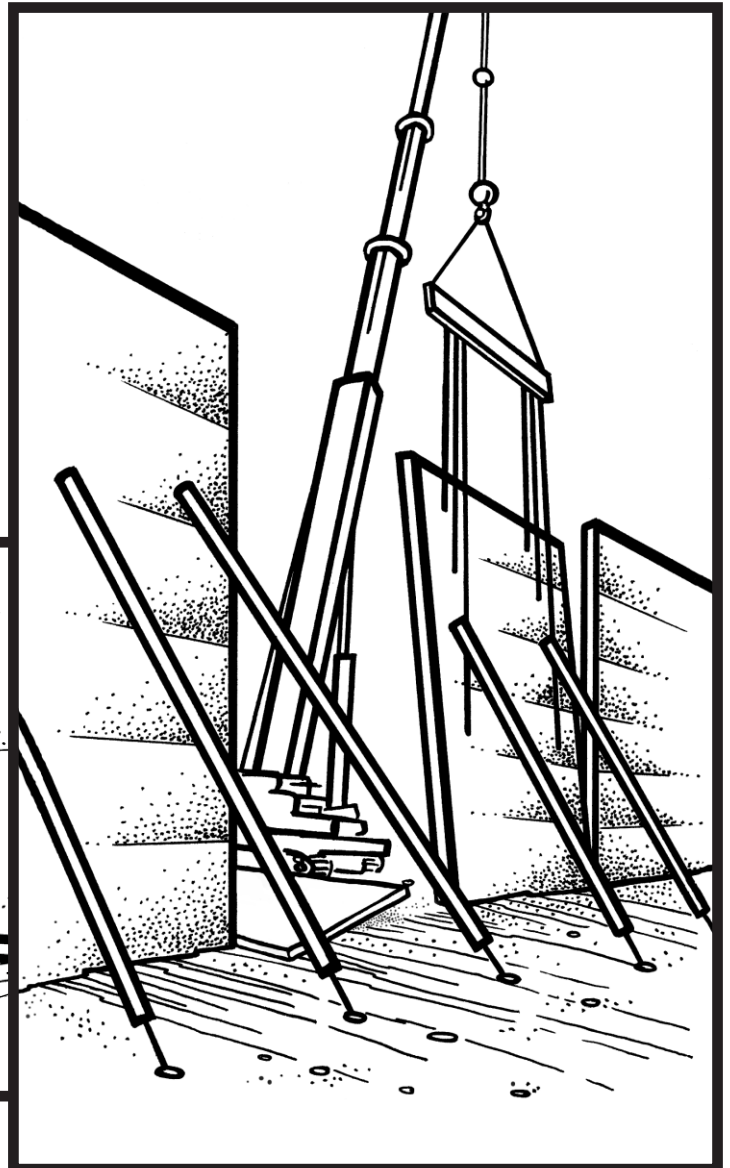
Employees were attempting to install a concrete pre-cast panel into position. As the operator of the crane attempted to position a piece of the wall, it came inwards of building. The operator then jerked it backward to try to compensate. At this time the walk-out wall clipped an adjoining tilt wall. As a result, the tilt wall fell down to the ground level causing total damage to the wall. In addition, one of the cranes outriggers got struck and damaged by the tilt wall as it came down. It's lucky no one was under the wall at the time.

The bottom line in this case is inexperience. The crane operator had not been properly trained for the job that he was required to do. The General Contractor should assure that all subcontractors that operate equipment (cranes, backhoes, skytraks) at any of their job sites have proof of proper training / certification and qualified experience for the equipment being used
