# TOOLBOX

## SAFETY TRAINING

### Vol 32 - No 2 ILLEGAL TOOL MODIFICATIONS

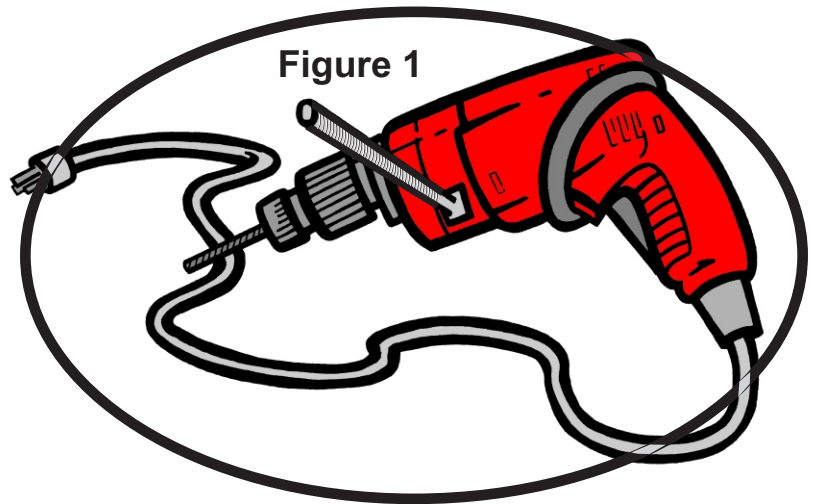
Figure 1

In figure 1, the drill is missing its side handle and someone has stuck a piece of unistrut thread in its place. It is extremely long and is likely to cut the user with its threads. Now the proper handle cannot be used, since the drill handle threads have been damaged by the unistrut.

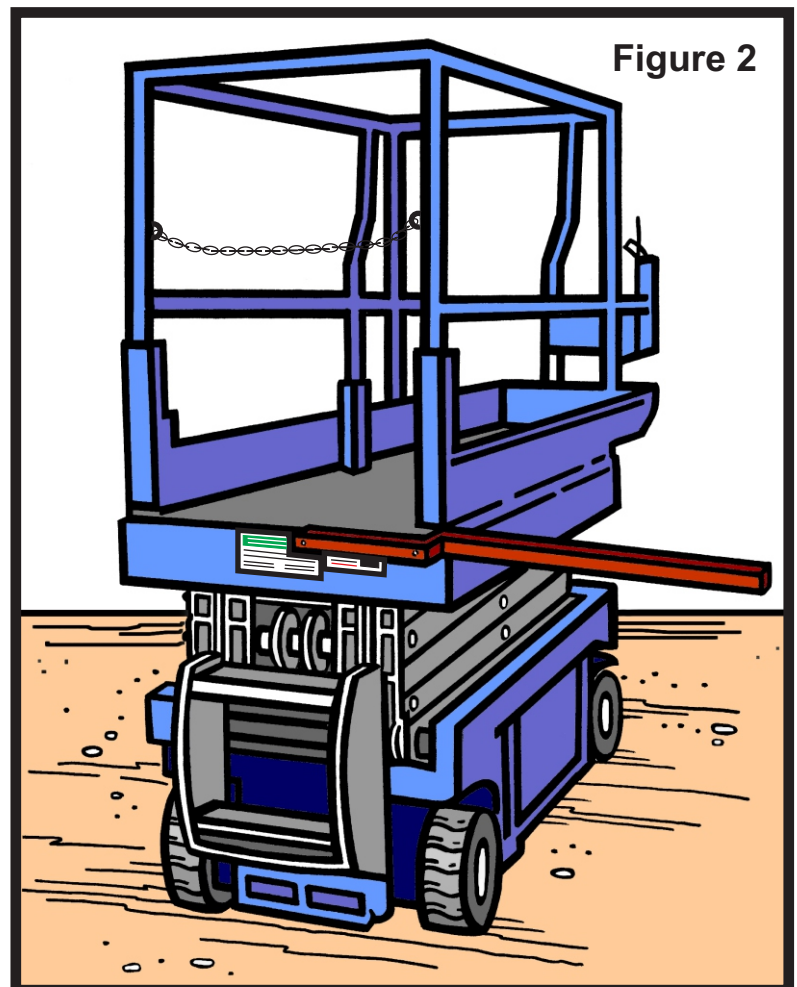
Figure 2

In figure 2, the scissor lift has a piece of angle iron attached at the exit point. This presents a puncture hazard to workers. The welding of the angle iron has also covered some warning signs, which is clearly prohibited by the manufacturer. In both instances there was no authorization from the manufacturer to perform the modifications.

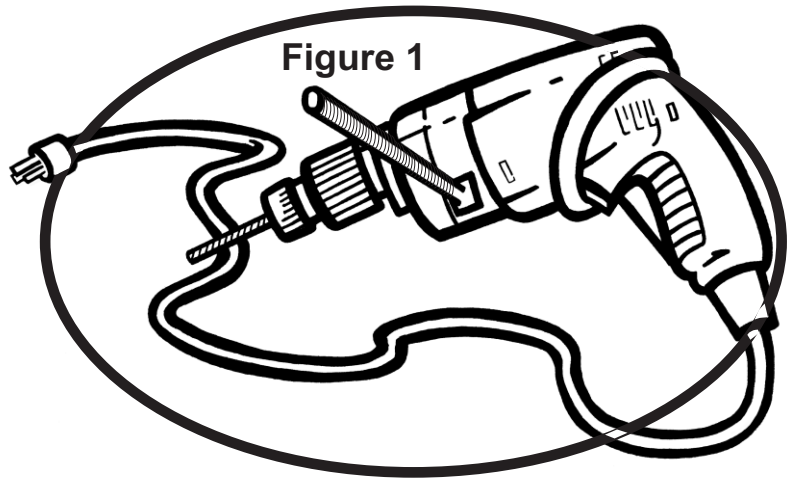
Figure 1

In figure 1, the drill is missing its side handle and someone has stuck a piece of unistrut thread in its place. It is extremely long and is likely to cut the user with its threads. Now the proper handle cannot be used, since the drill handle threads have been damaged by the unistrut.

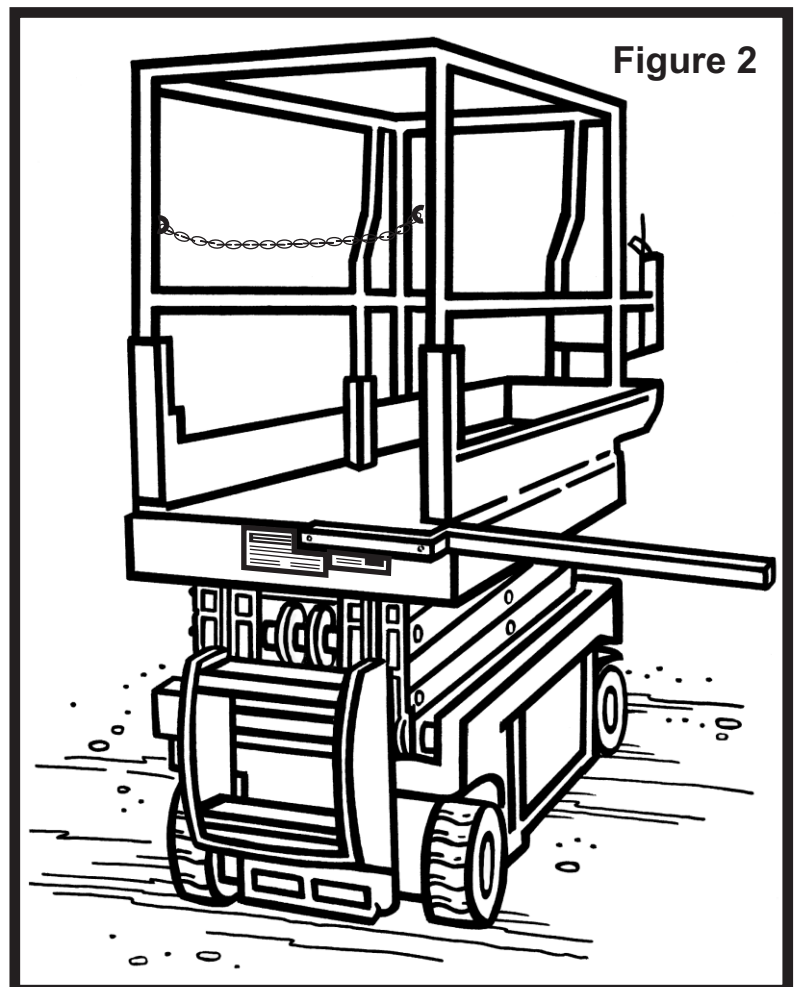
Figure 2

In figure 2, the scissor lift has a piece of angle iron attached at the exit point. This presents a puncture hazard to workers. The welding of the angle iron has also covered some warning signs, which is clearly prohibited by the manufacturer. In both instances there was no authorization from the manufacturer to perform the modifications.
