TOOLBOX

**SAFETY
TRAINING**

Vol 32 - No 30

CIRCULAR SAW ACCIDENT

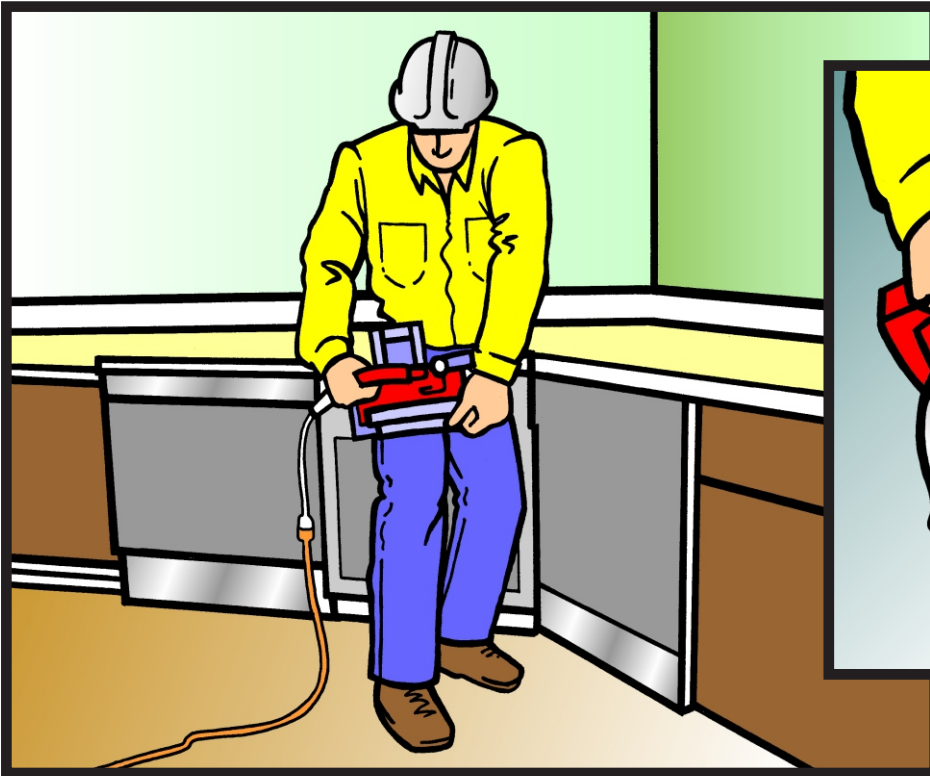
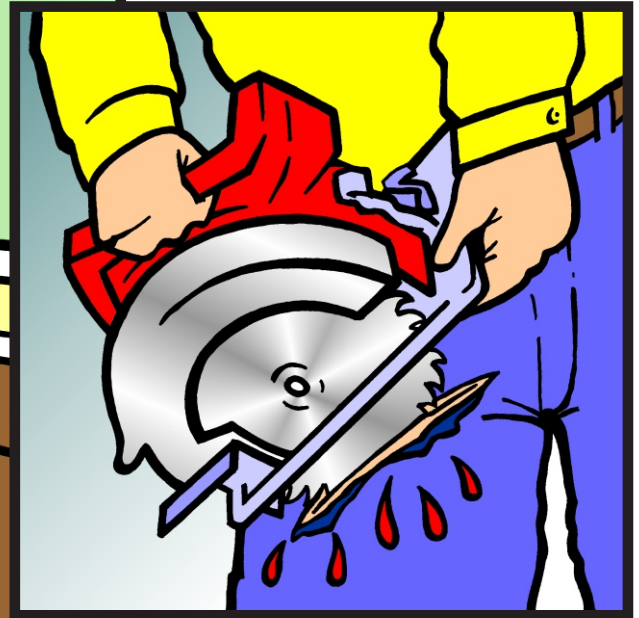
A carpenter was using a circular saw to cut a section of counter top to place on cabinets. As he finished his cut, he placed the saw against his right leg as though to rest the saw for his next cut. He suddenly felt a tingly sensation on his leg and proceeded to look down. His leg had been severely cut and he had to be rushed to the hospital. The cut was so serious that it required over 150 stitches to close the wound and was 1/4" away from having the leg amputated.

Upon the investigation of the accident, it was discovered that the major factor contributing to the injury was that the circular saw had a defective blade guard. The accident could easily have been prevented if the tool had been inspected to make sure it was in good working order and that the guard was properly in place. If power tools are found to be unsafe, they must be tagged out and stored away for repair.

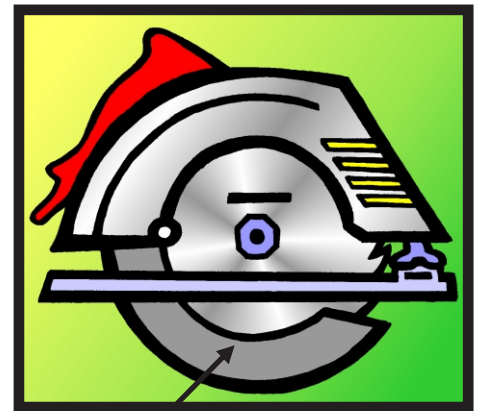
**WHEN THE SAW
BLADE GUARD IS IN
PLACE, IT COVERS
THE TEETH AND
PROTECTS FROM
UNWANTED
CONTACT**

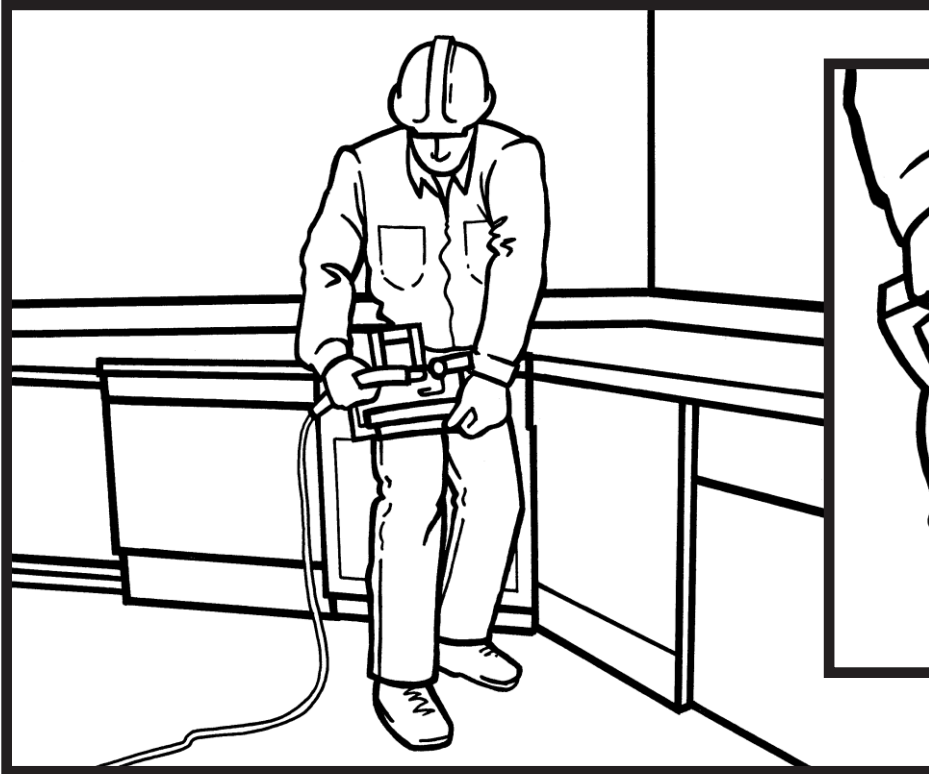
A carpenter was using a circular saw to cut a section of counter top to place on cabinets. As he finished his cut, he placed the saw against his right leg as though to rest the saw for his next cut. He suddenly felt a tingly sensation on his leg and proceeded to look down. His leg had been severely cut and he had to be rushed to the hospital. The cut was so serious that it required over 150 stitches to close the wound and was 1/4" away from having the leg amputated.

Upon the investigation of the accident, it was discovered that the major factor contributing to the injury was that the circular saw had a defective blade guard. The accident could easily have been prevented if the tool had been inspected to make sure it was in good working order and that the guard was properly in place. If power tools are found to be unsafe, they must be tagged out and stored away for repair.

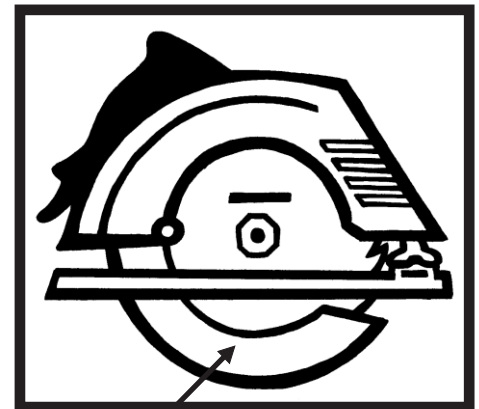
**WHEN THE SAW
BLADE GUARD IS IN
PLACE, IT COVERS
THE TEETH AND
PROTECTS FROM
UNWANTED
CONTACT**
