TOOLBOX

SAFETY TRAINING

Vol 31 - No 32 HAND TOOL SAFETY

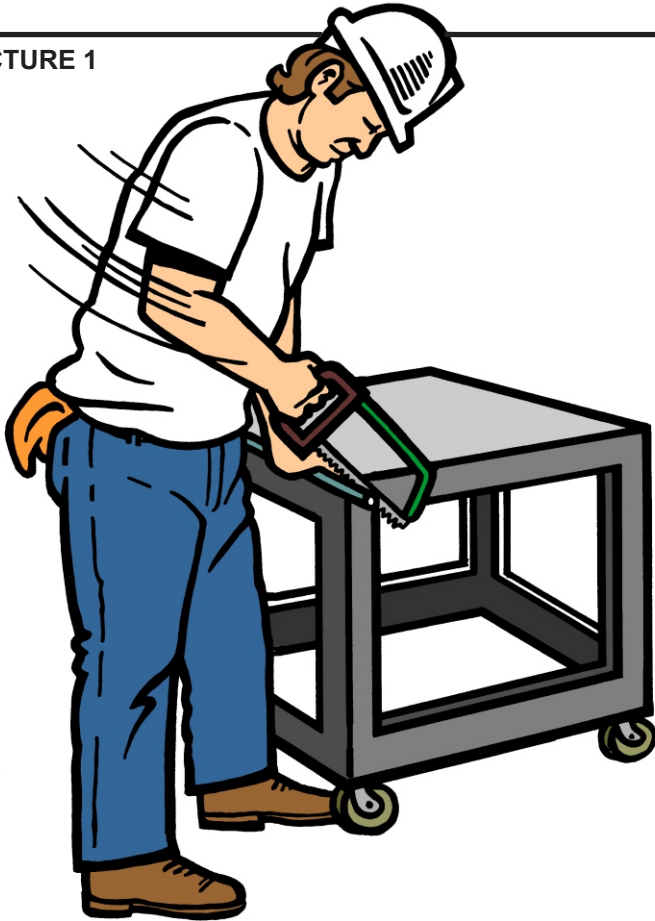
PICTURE 1

Take of instance an electrician cutting a length of conduit as in picture 1. We hold the conduit in one hand and cut vigorously with the other (picture 2). Once the hacksaw cuts through, unless the arm force is not controlled in time one could seriously cut a finger on the sharp edge of the conduit (picture 3).

This accident occurs frequently in the electrical trade. Frequency can be reduced by making electricians aware of this problem and / or requiring leather work gloves during the cutting process.

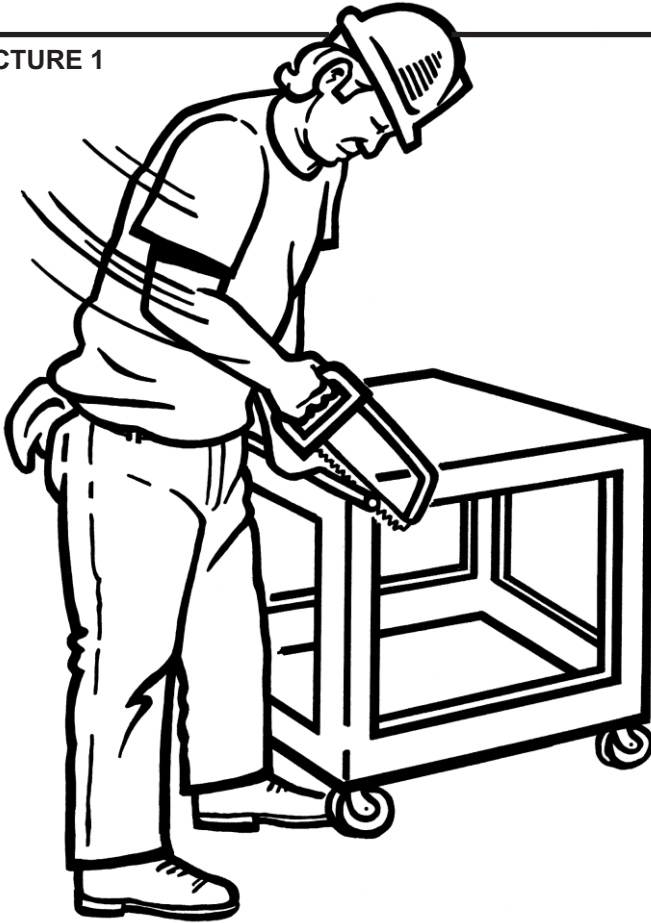
PICTURE 1

Take of instance an electrician cutting a length of conduit as in picture 1. We hold the conduit in one hand and cut vigorously with the other (picture 2). Once the hacksaw cuts through, unless the arm force is not controlled in time one could seriously cut a finger on the sharp edge of the conduit (picture 3).

This accident occurs frequently in the electrical trade. Frequency can be reduced by making electricians aware of this problem and / or requiring leather work gloves during the cutting process.
